SUBJECT: SPECIAL SERVICE CAMPAIGN - 601

(CERTAIN 2001 THROUGH 2003 MODEL YEAR 4-CYLINDER HIGHLANDER AND CERTAIN

2001 THROUGH 2002 MODEL YEAR RAV4 ECM REPROGRAMMING)

CERTAIN 2001 THROUGH 2003 MODEL YEAR 4-CYLINDER
HIGHLANDER
AND CERTAIN 2001 THROUGH 2002 MODEL YEAR
RAV4
ENGINE CONTROL MODULE REPROGRAMMING

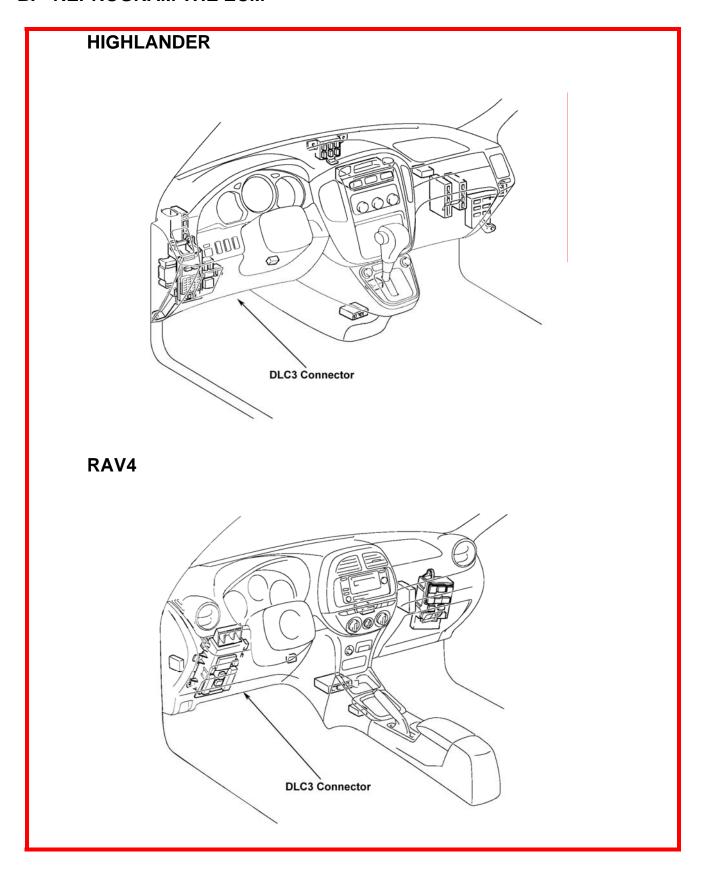
B. REPROGRAM THE ECM

1. REPROGRAMMING PRECAUTIONS

- a) Turn OFF all electrical accessories (i.e. audio systems, dome lamp, air conditioner, etc.) to avoid drops battery voltage while reprogramming the ECU.
- b) Using the Midtronics Battery Tester, confirm that the battery voltage is greater than 11.4 volts.
 - If the voltage is less than 11.4 volts, charge and retest the battery as necessary.
 - The battery must be fully charged before proceeding to the next step.
- c) Connect a battery charger to the vehicle.

DO NOT use a jumper battery in place of the battery charger or irreparable damage to the ECM may result.

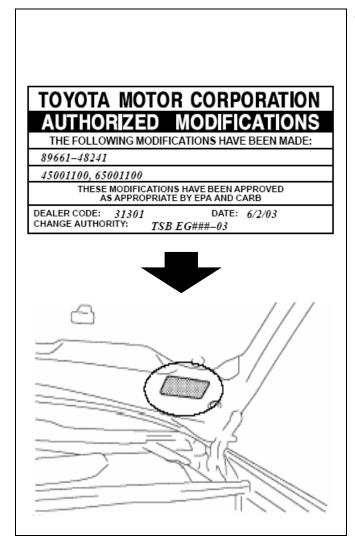
C. INSTALL THE RECALIBRATION LABEL

1. RECALIBRATION LABEL INSTALLATION

- a) Using a permanent marker, write the appropriate information on the recalibration label:
 - ECU Part Number
 - Calibration Number
 - Dealer Code
 - Repair Date
 - Change Authority
 - Service Campaign No. 60I
- b) Install the Recalibration Label on the underside of the hood in front of the driver (see illustration).
